WASTE WATER TREATMENT PLANT AND INCINERATOR COMPLEX,
SITES 5EP2447 AND 5EP2446,
FORT CARSON, COLORADO

James Schneck
and
Karin M. Roberts

United States Department of the Interior
National Park Service
Midwest Archeological Center
Lincoln, Nebraska

September 1998

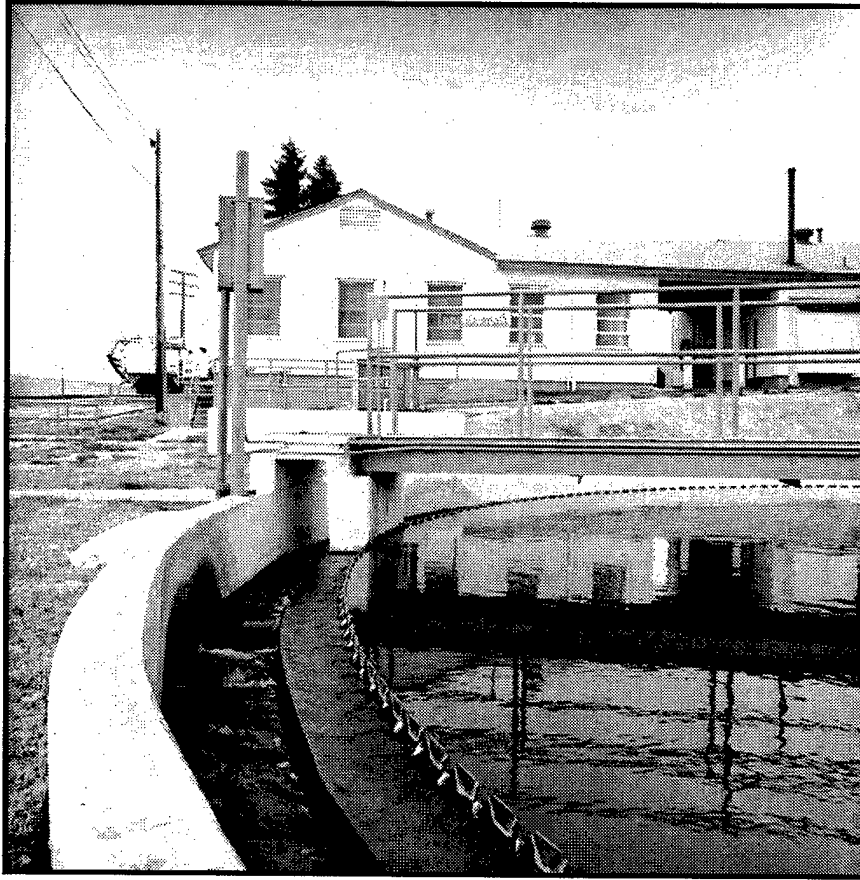
Figure II-69. Detail View of Typical Secondary Clarifier Weir Plate, Effluent Drain, and Walkway. View of Secondary Clarifier 3888. Roll HH20, Exposure 6.

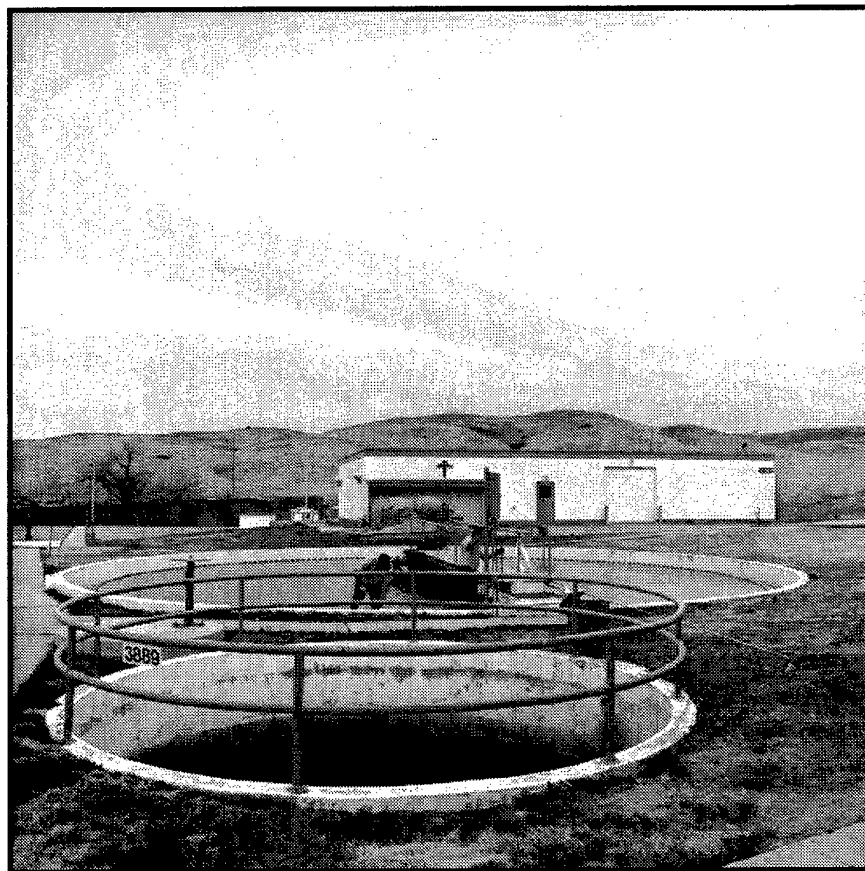
Figure II-70. View of Recirculation Well 3889 to the Southeast. Secondary Clarifier 3892 in Background. Roll HH23, Exposure 6.

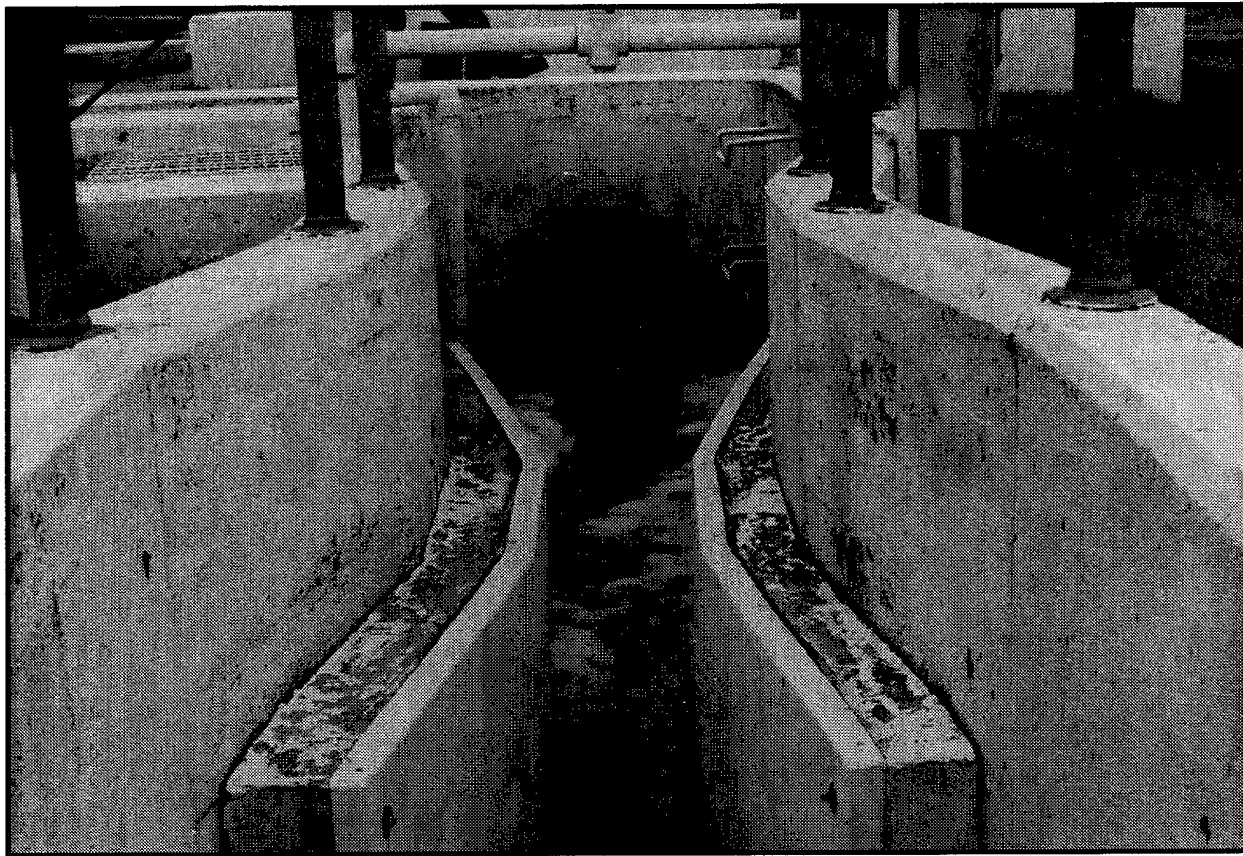
Figure II-74. View of Diversion Box/Parshall Flume 3893. View Upstream Through Flume. Note 1981-era Modification That Narrowed Flume. Roll MWAC3, Exposure 21.

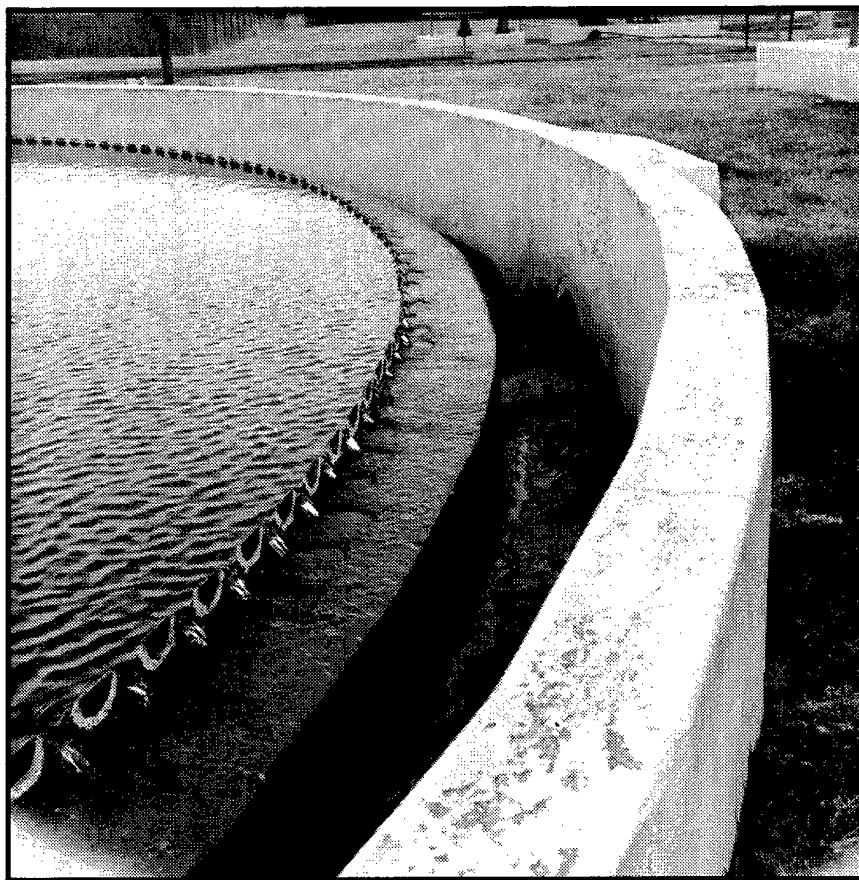
Figure II-76. Detail View of Typical Secondary Clarifier Weir Plate and Effluent Drain. View of Secondary Clarifier 3895. Roll HH22, Exposure 5.

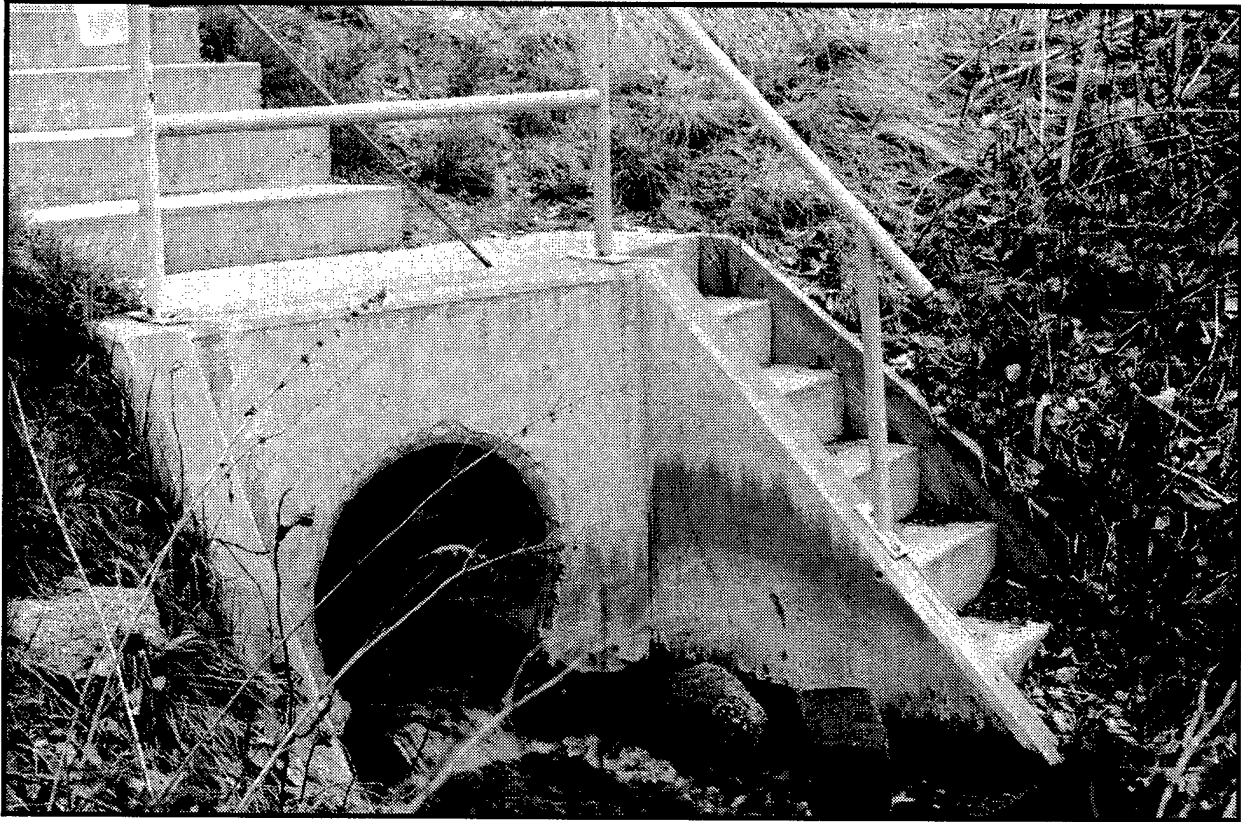
Figure II-77. View of Effluent Outfall at Clover Ditch to the Northeast. Outfall's Method of Constuction Suggests It Dates From 1980s. Roll MWAC3, Exposure 24.

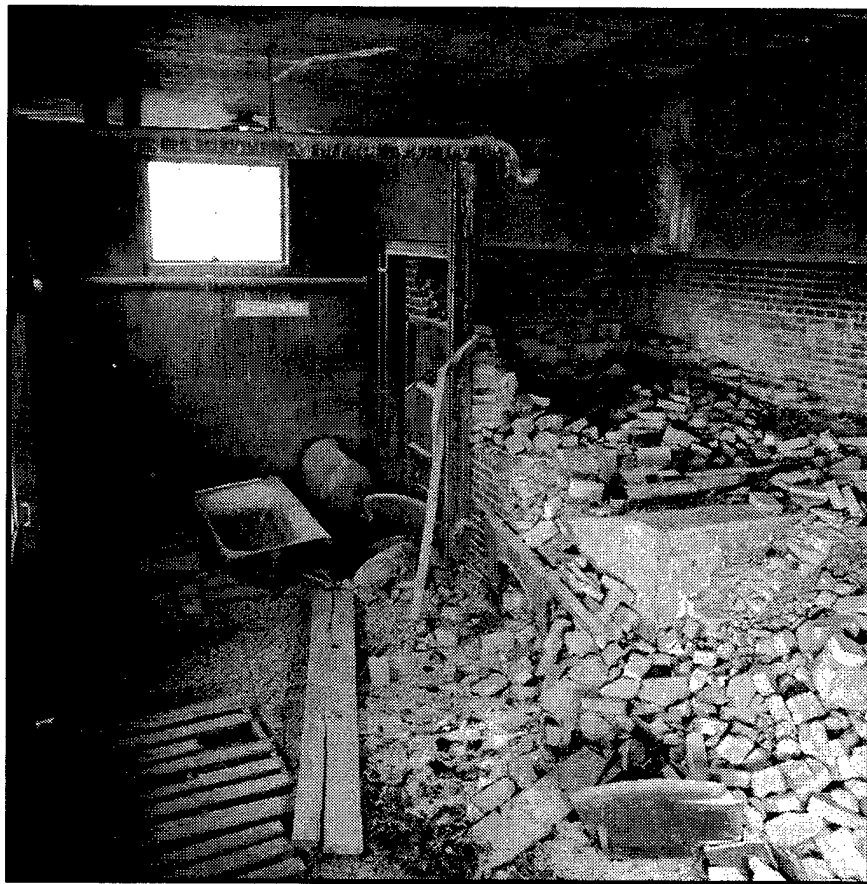
Figure II-81. Interior View of Basement at Incinerator 3850. View to the West. Brick Remains of Incinerators Visible to Right. Roll HH4, Exposure 6.

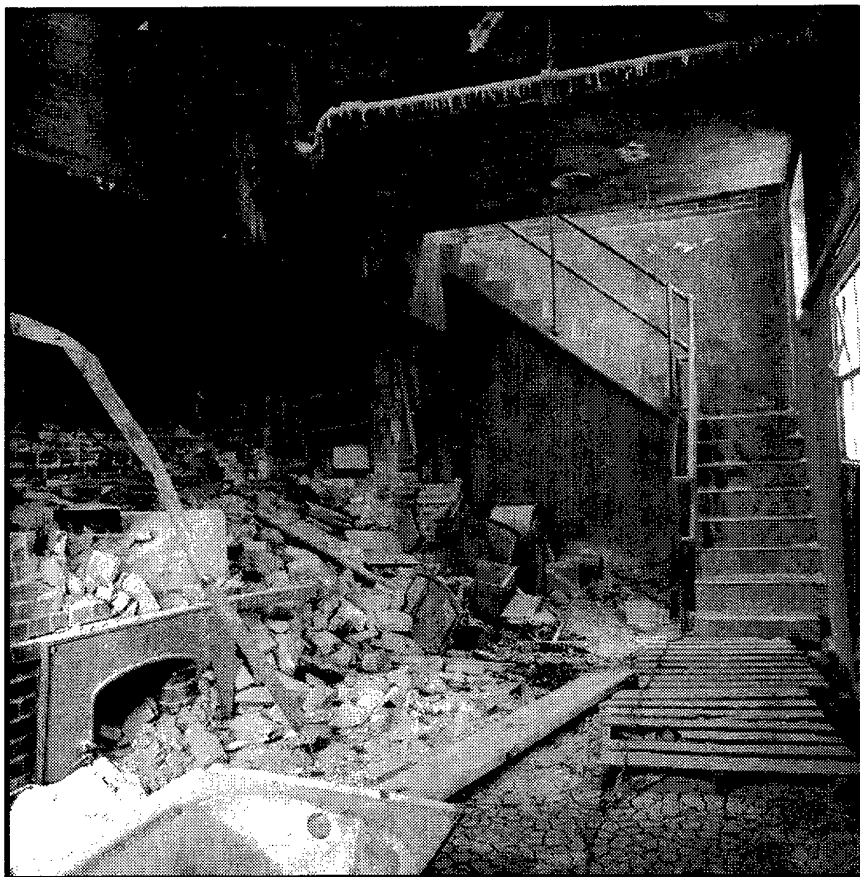
Figure II-82. Interior View of Basement at Incinerator 3850. View to the East. Remains of Incinerator Furnaces Visible in Photograph. Roll HH4, Exposure 8.

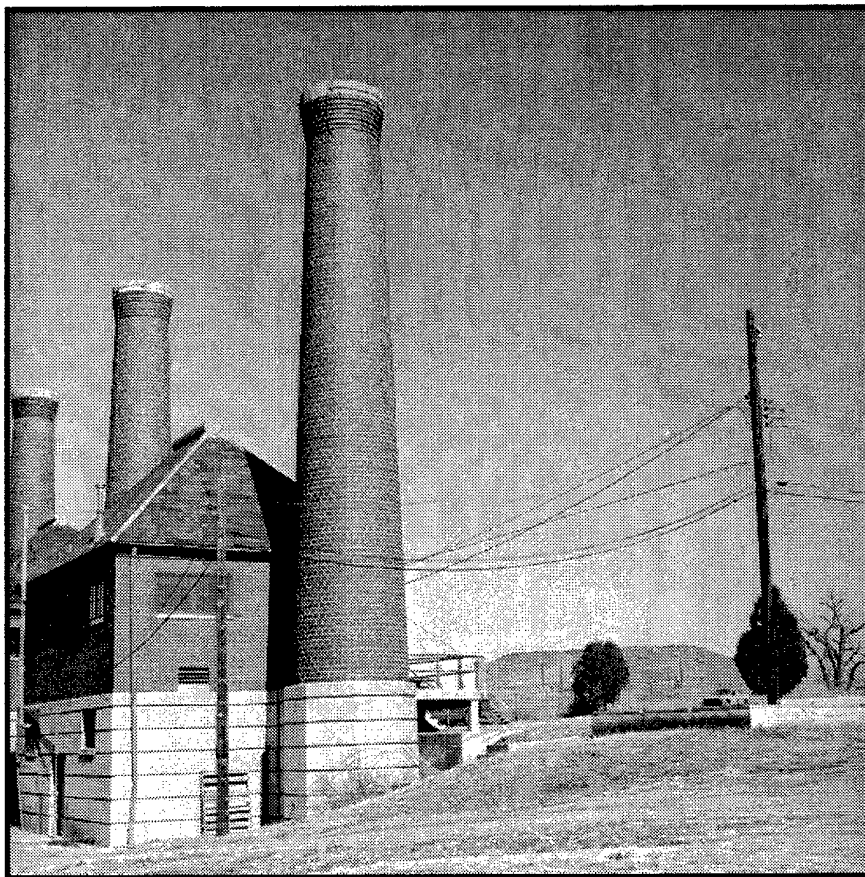
Figure II-88. 3/4 View of South and East Faces of Incinerator 3852. Grease Trap and Foundation of Incinerator Lavatory 3853 Visible to Right of Chimney. Roll HH4, Exposure 5.

Incinerator Lavatory 3853 originally housed a shower and lavatory for incinerator workers. The building later housed a generator before being demolished in 1995 (Figure II-9). All that remains today is a concrete floor and foundation.
